**North Slope of Alaska ARM Facilities  
Monthly Status Update  
Sandia National Labs**

**August 2017**

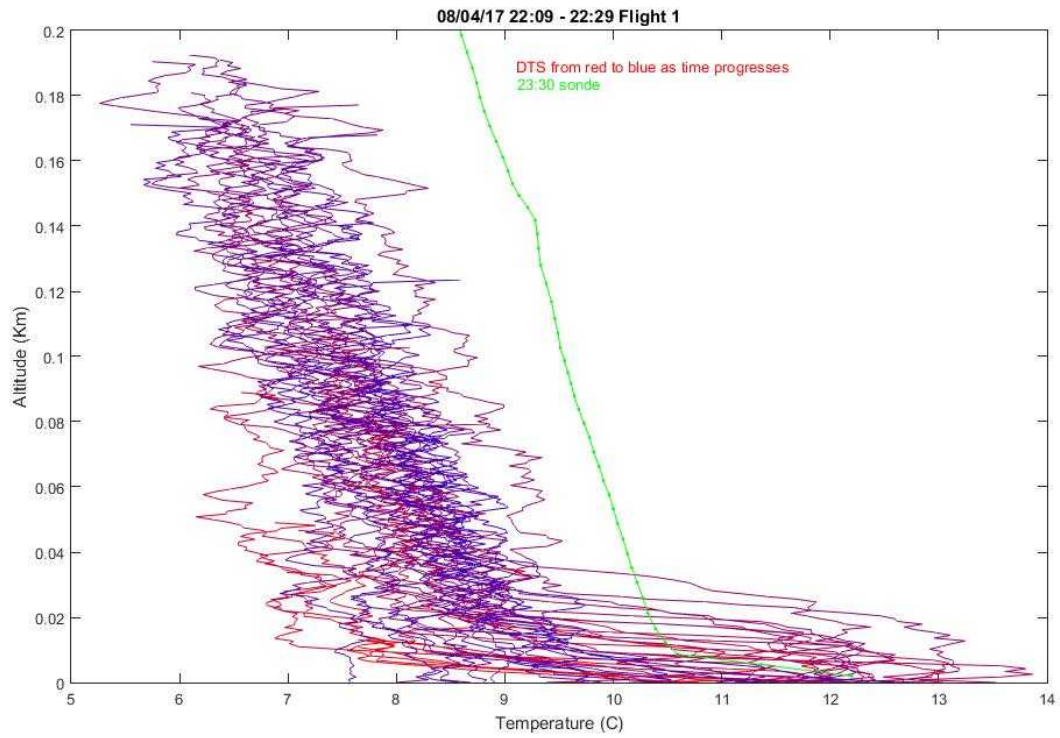
Comparisons from 08/04/17 TBS DTS through the radiosonde joint appeared to compare well. There is some excess heat in the lowest 150m of the fiber trace due to friction within the rotary joint as it spins.

Figure 5: TBS DTS through FORJ on Flight 1 on 08/04/17

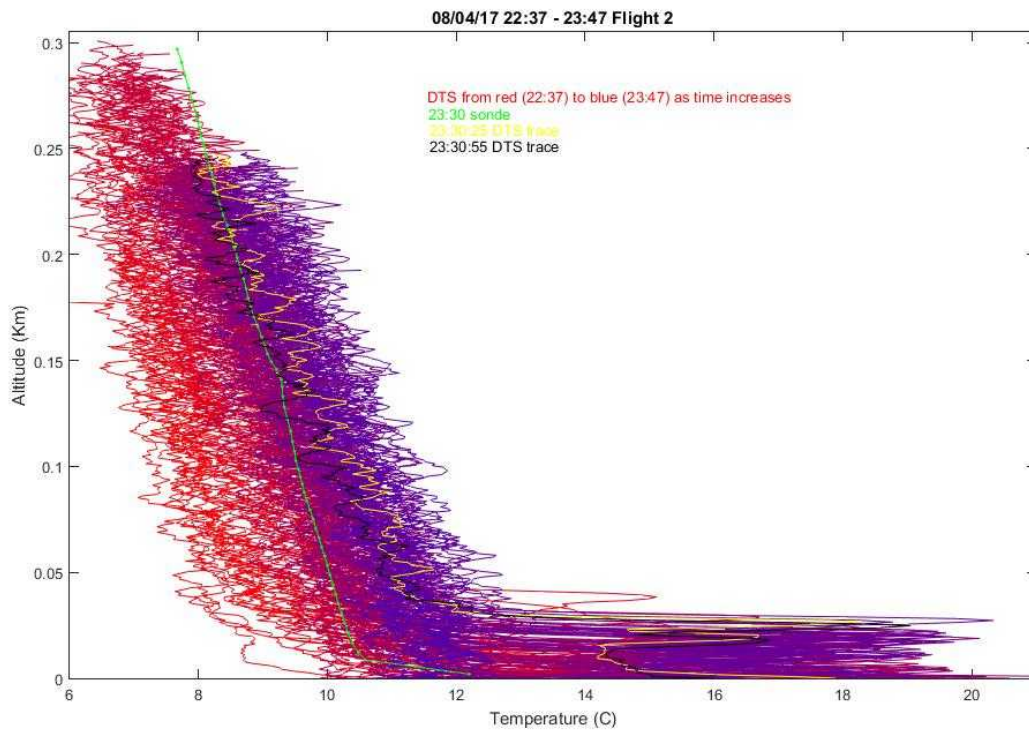
Figure 6: TBS DTS through FORJ on Flight 2 on 08/04/17

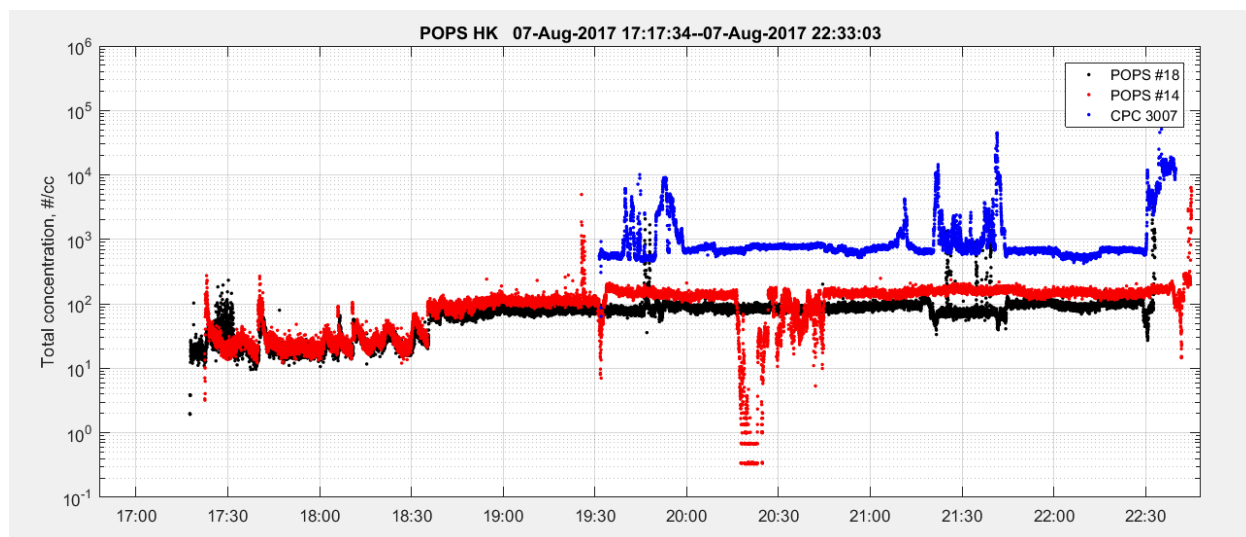
**Notable Events:** POPS SN14 has experienced intermittent problems since April, and been returned to the vendor twice for troubleshooting. On the 08/06/17 flight the POPS particle count was 0 shortly after launch. On today's flight the POPS functioned better but still had problems at altitude. Handix thinks this could be EMI-related. We have grounded the POPS backplane to the metal enclosure.

Figure 11: Fan Mei's plot of POPS and CPC data from 08/07/17, POPS SN14 anomalous at higher altitudes.

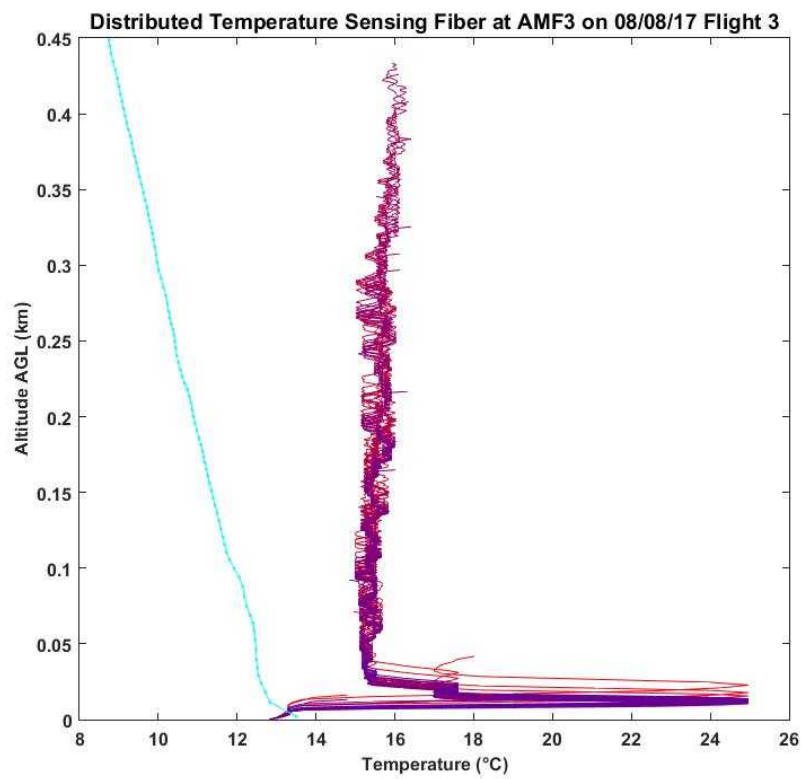
Three JUBA IOP flights were conducted at the Sandia site using an iMet radiosonde, iMet XQ sensor, and DTS with the rotary joint. There were approximately 50 minutes of flight time total. The first two flights ascended to 200m, and the last to 425m. When compared to the sounding the DTS below the octocopter was too warm, likely due to being run through a heat tray at the surface in order to identify the surface. The short nature of the octocopter flights, < 15 minutes, likely caused the fiber to remain too warm when compared to ambient. Analysis is ongoing.

Figure 18: JUBA IOP octocopter DTS temperatures at Sandia site from 23:45-00:00 vs 23:30 AMF3 radiosonde

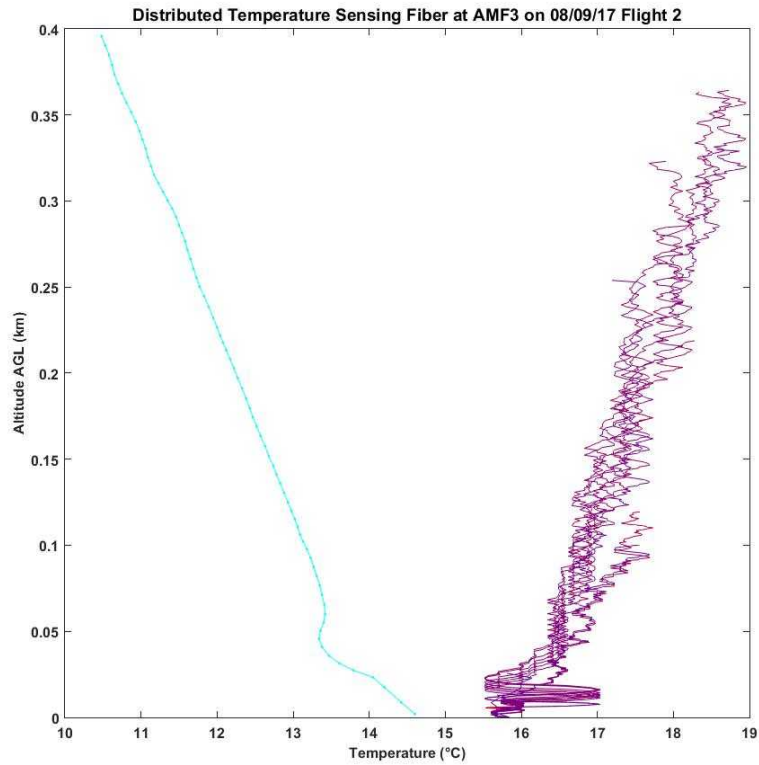
Unfortunately the TBS DTS fiber suspended on the helikite for comparison purposes with the octocopter DTS broke shortly after launch. Again, when compared to the sounding the DTS below the octocopter was too warm, likely due to being run through a heat tray at the surface in order to identify the surface.

Figure 20: JUBA IOP octocopter DTS temperatures at Sandia site from 23:36:55 vs 23:30 AMF3 radiosonde
